The catastrophic repairs of Holyrood Abbey church in 1760

Dimitris Theodossopoulos, Lecturer in Architectural Technology and Conservation

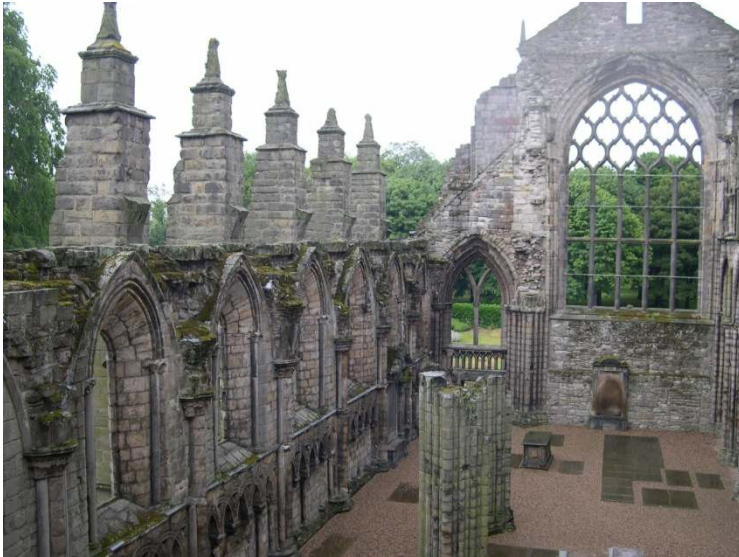
Figure 1. The current state of the abbey church of Holyrood (2010) following no major interventions after the collapse of 1768

The examination of the remains (Fig. 1, 2 and 16) and the report by W. Mylne immediately before the collapse (see appendix and Mylne 1766) may offer more clues on the dynamic of the collapse. The study of the surviving piers shows a few distortions that are remnants from the collapse but their cross section was not weakened from the 1633 and 1687 fittings any more particularly compared to the South arcade (certainly, these are the piers that survived the collapse). It is not certain whether the demolished ones are those that gave way or where most of debris fell. The damage appears to have occurred closer to the West façade (which as seen later had to be strengthened in 1626), and at higher level as the towers had to be removed by Mylne, while the East gable (much less robust than the West front, but also rebuilt in 1626) was not damaged much. Most probably all loose fabric was removed immediately after the collapse as there were no funds for consolidation. It is also probable some damage must have happened during demolition as well.

in 1795 and was rebuilt in 1816 (Robertson and Crae 2005). Damages on the internal face of the North walls (Figs 1, 2) are spread across the upper levels (around the windows mainly), and a few more severe ones can be detected closer to the W end, like some missing shafts on the piers and lower blind decorative arcades.

Most of the debris was cleared afterwards by W. Mylne, while this probably continued until 1856 (Robertson and Crae 2005). In the discussion about the necessary works (Exchequer Court 1769), he is asked to build up most of the windows and the stair door, for safety reasons, while he was allowed to sell any valuable remaining dressed stone. Special mention is also made on the flagstones that survived the fall of the roof to be put carefully aside. No mention is made on structural repairs, but all loose vaults are taken down, including the entire North aisle, but the outer wall survives to the height of the lancet windows (Figs. 1, 2, 16).

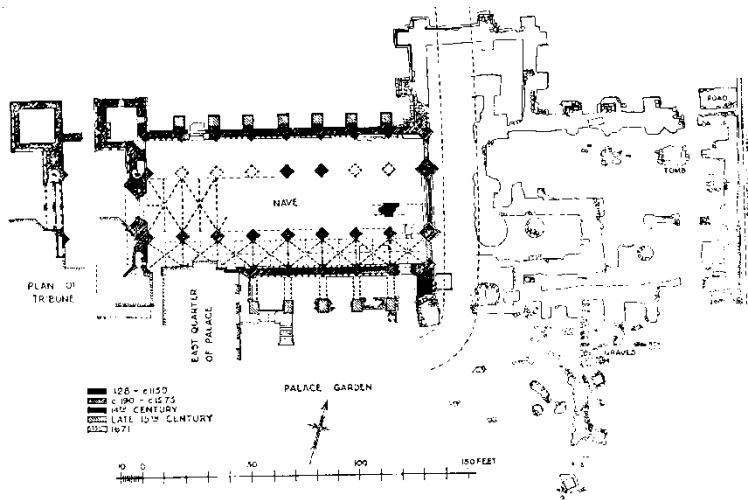
Figure 2. Plan of the development of the abbey (Oldrieve 1911)

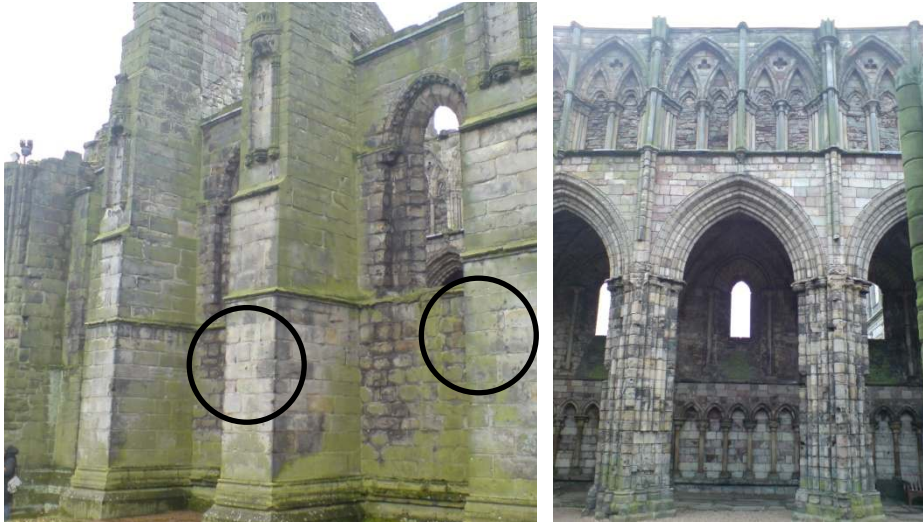
Figure 3. Evidence of gunfire damage at the exterior (from the 1544 invasion) and deep cuts on the shafts of the piers for the insertion of pews at the interior during the extensive refurbishments of 1633 and 1670.

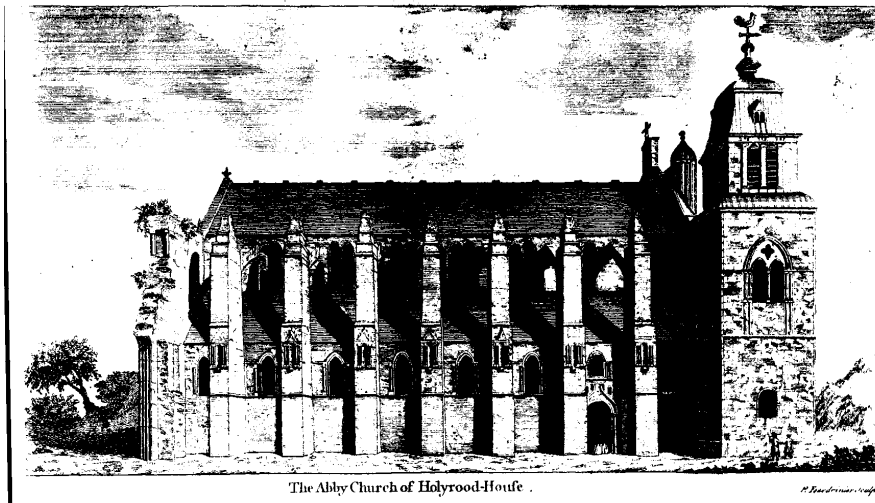
Figure 4. The abbey church in 1753, showing some of the decay that required the intervention in 1760 (Maitland 1753)

were probably deemed to be safe (Fig. 4) and this reduced the budget. No major replacement of the aisle roofs is mentioned in the 19th and 20th century and their condition is still quite good (Fig. 6).

In addition to these estimates, an inspection of the roof of the remaining S aisle shows the covering is stone tiles (Fig. 5). It is highly probable the nave roof had originally the same covering (Fig. 4), which could have been simply re-located after the repair. If flagstones were used on the other hand, no mention is made in any of the Exchequer minutes that the stone tiles were carefully stored, although they could have been re-used in Edinburgh Castle (the Great Hall, for example).

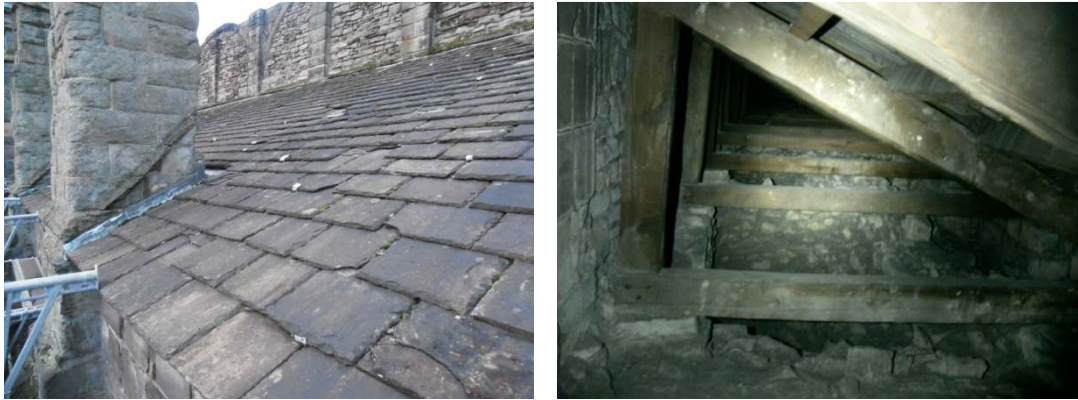
Figure 6. Aisle roof: Covering with stone tiles, similar to what probably used to cover the nave, and internal view of the intrados space (taken in Summer 2013).

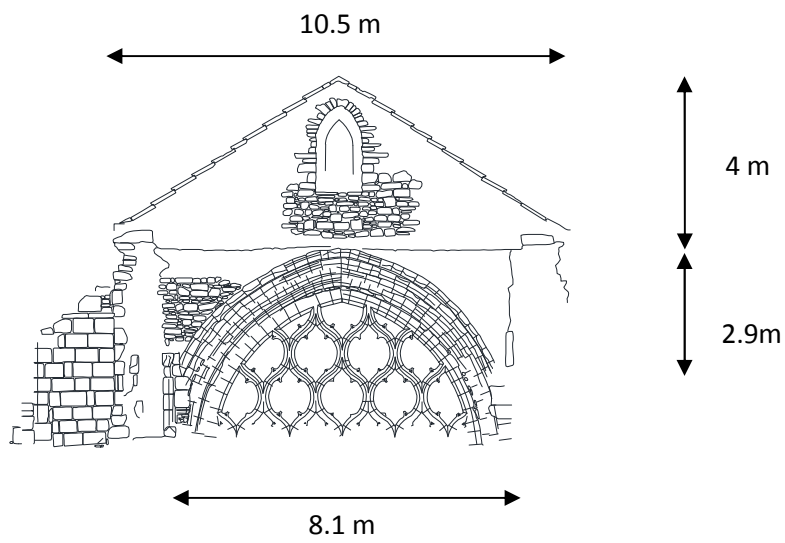
Figure 7. Survey of the East gable (Robertson and Crae 2005) and dimensions of the nave vault

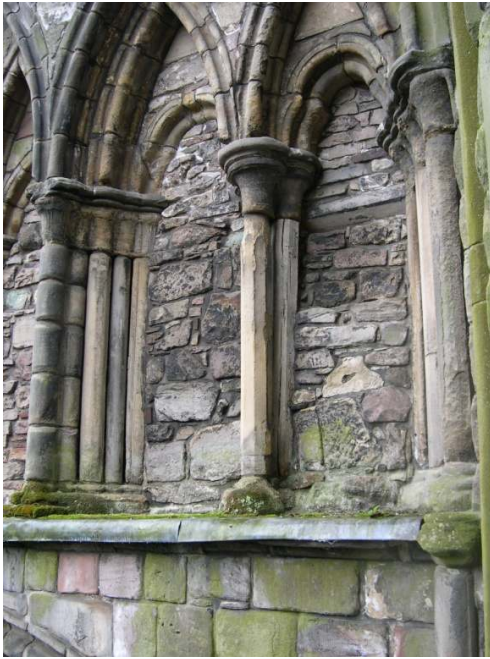
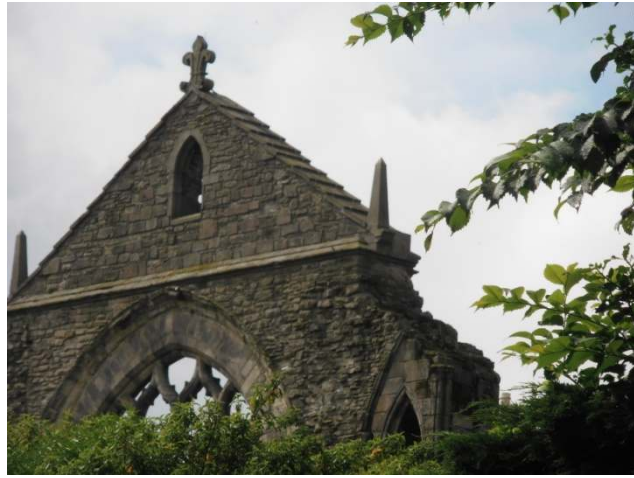
Figure 8. Remains of the Douglas and McPherson project at the rubble stonework blocking the openings of the triforium (item 8 in Table 1) and possibly the coping stones at the W gable window (but not the obelisks and fleur-de-lis finial).

Following the collapse, few remains survive from the repair project. The triforium windows ("where the Stone Roof of the Isles is to join to the side walls of the Main Body of the Church") were blocked with "Rubble Building" (Fig. 8) during that project (item 8 in table 1). If the estimated area of the openings is 60% of the corresponding band of the triforium, this is then $(38.7 * 2.2) * 2 * 0.6 = 102 \text{ m}^2 = 127 \text{ sq yards} = 4 \text{ roods and } 6 \text{ yards}$, which is close enough to 4 Roods 26 yards mentioned in Table 1. Coping stones are still fixed along the W gable which together with the obelisks at the base of the gable may have been an attempt to visually tidy up the edge of the renovated roof, especially when seen against the original pinnacles over the piers of the flying buttresses.

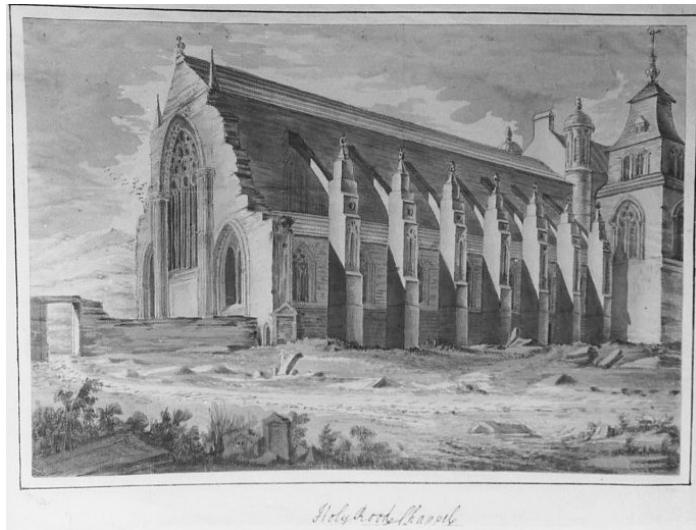
Figure 9. The Abbey Church in 1765 ("View of Holyrood Chapel") in an engraving by Richard Cooper jun. (Richard Cooper 2015)

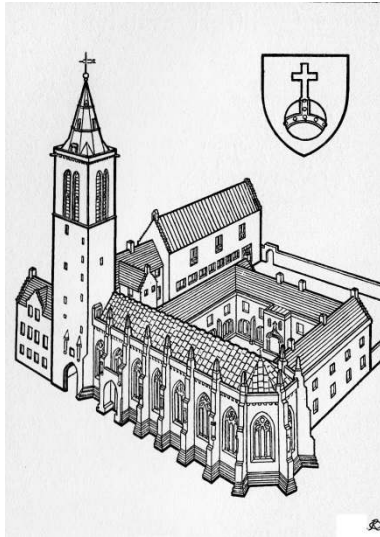
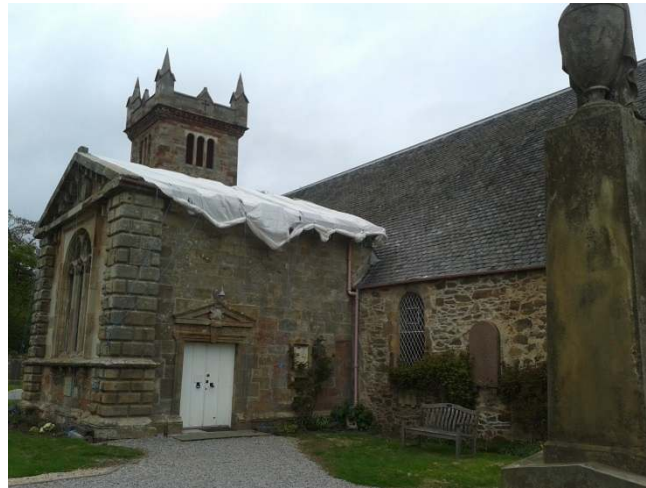
Figure 10. St. Salvator's Chapel in St. Andrews University before the forced collapse of the roof in 1773 (Cant 1956) and Dirleton Aisle (East Lothian), built in 1664.

This is in a clear contrast to British empiricism. No similar spatial or structural complexity is observed in British architecture of the time, with vaults even being misunderstood (Fig. 10) and mostly new barrel vaults would be built for bridges as Piranesi's engravings for the construction of Robert Mylne's Blackfriars Bridge during construction in 1764 show.

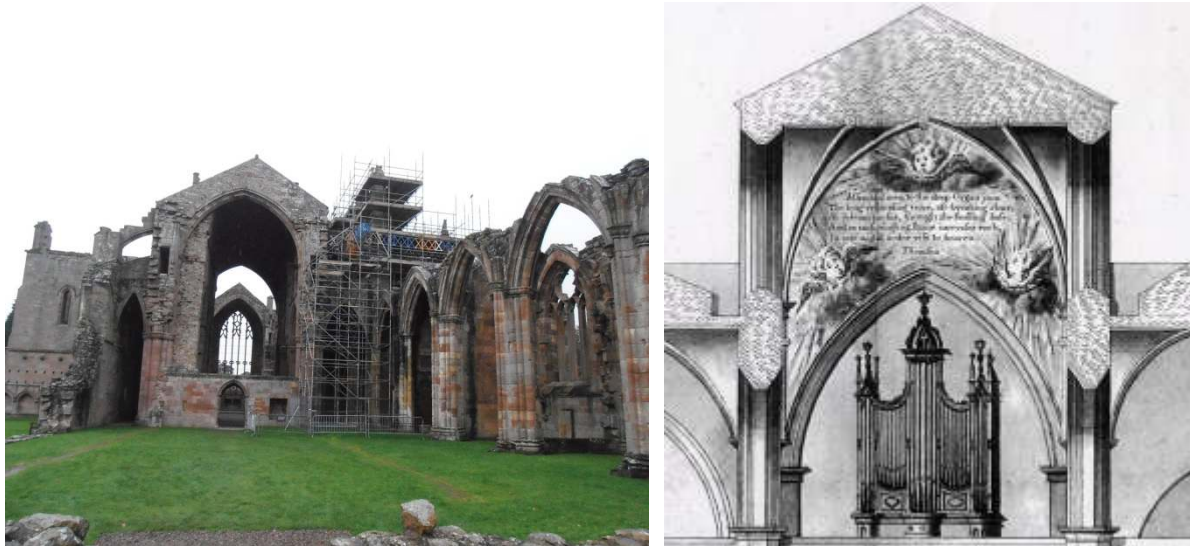
Figure 11. Misinterpretations of vault design in post-reformation Scotland: the barrel vault that replaced the nave cross vaults in Melrose ca 1621 and James Craig's design of the King's Seat in St. Giles, Edinburgh in 1777 (NMR catalogue number C 96508 PO)

To highlight the architectural context in Scotland further, earlier ca. 1621 in Melrose Abbey a new barrel vault was built to roof the nave, then serving as the parish church, with clearly no intention to repair or restore the ribbed vault of the pre-Reformation church (Fig. 10). In a period when no major vaults are being built any more, these examples can make the vaults in Holyrood to be misinterpreted as barrel vaults. Their strength would then be overestimated, exacerbated by the lack of interest in the role of buttresses and understanding of the containment of thrusts (as a complex structural system). A further indication of this misunderstanding of function can be seen in

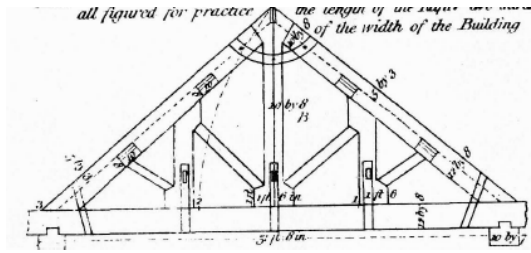
Figure 12. Form of 18C king post trusses from William Pain (1794)

A king post would have been the original design since access to the ridge of the stone vault of the nave would not be required as much as in major cathedrals like Lincoln or Durham, where queen post roofs were built. Even though during the period of the repairs many Gothic cathedrals were re-roofed in Britain (e.g. East end of Ely by James Essex in 1757-62) in queen post trusses (more effective than king posts for their steep pitches as the principal rafters were easier to strut, Yeomans

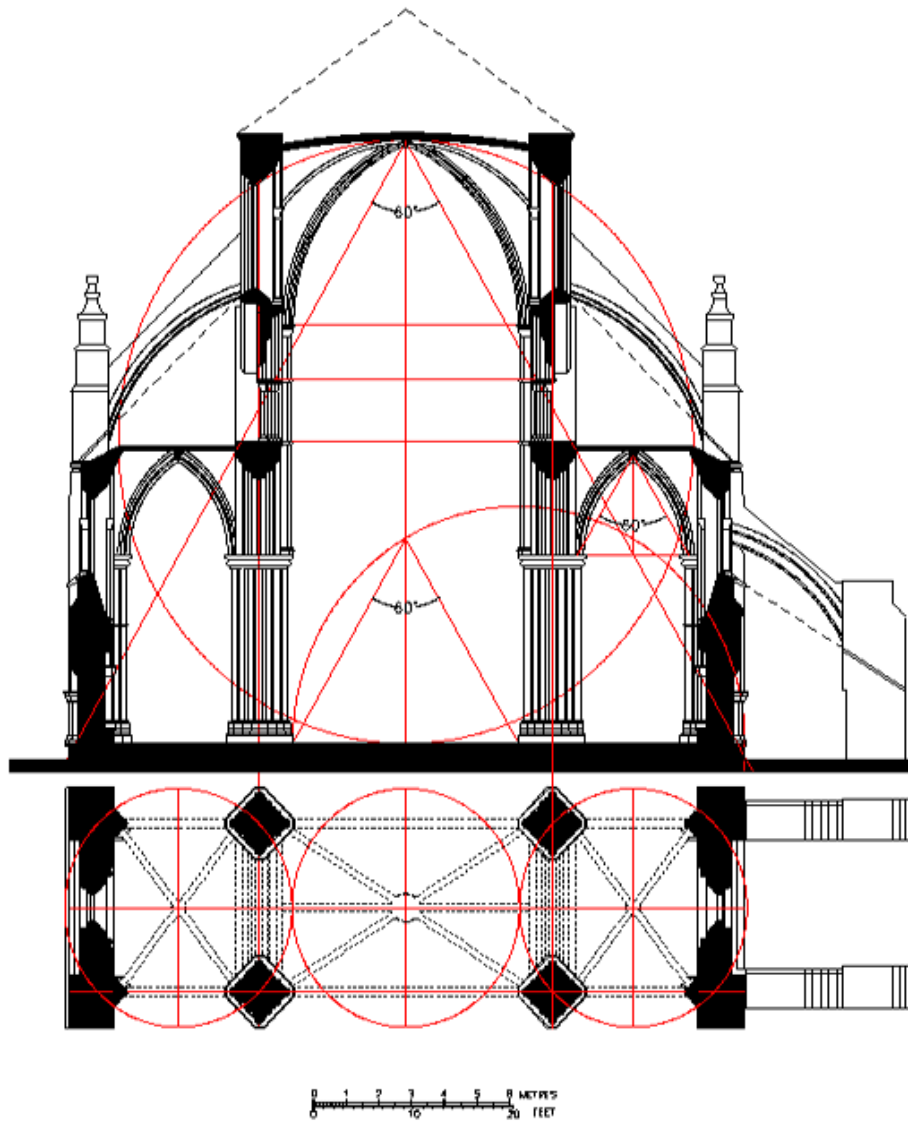
Figure 14. Hypothesis on the original configuration of the nave, considering a sexpartite one for the high vaults (Theodossopoulos et al 2003)

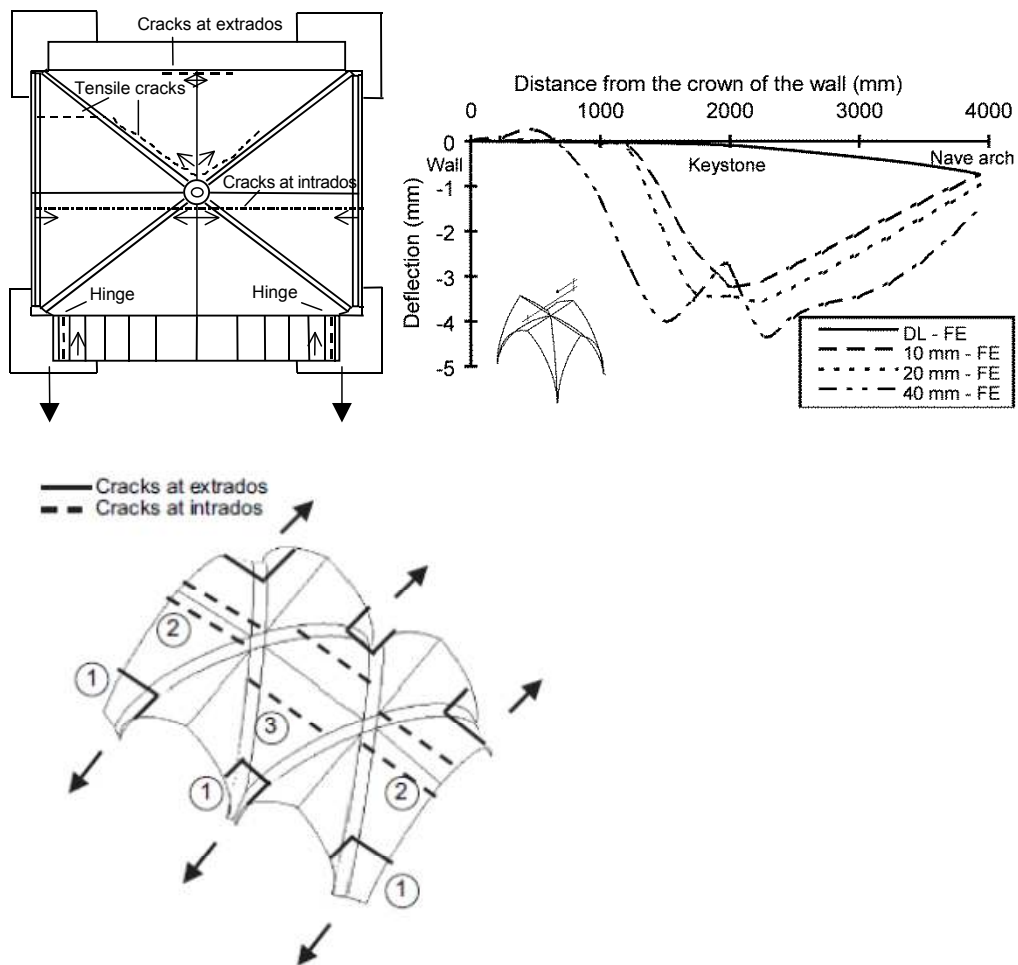
Figure 15. The crack pattern of an experimental model simulating the aisle vaults in Holyrood at 30mm support spread; the deflections of the symmetry axis of a FE model of the aisle (Theodossopoulos et al 2003); and crack pattern on a typical nave vault from Durham Cathedral (Theodossopoulos 2008)

Earlier experimental and numerical analysis of the collapse mechanism of the aisle vaults due to lateral support spread (Theodossopoulos 2001, 2003, 2008) indicated the limits of this instability (135mm or 1/28 of the transverse span 3.8m). The ensuing failure pattern of the aisle (Fig. 15) is caused by the development of a mechanism formed by three hinge lines along the wall, longitudinal axis and back ribs, and the base of the nave arch. A similar pattern characterises the nave vaults (longitudinal and nave arch cracks), as the simulation of the ones in Durham (Theodossopoulos 2008) indicate they can fail numerically at 330mm symmetric spread (or 1/34 of 11.2m span).

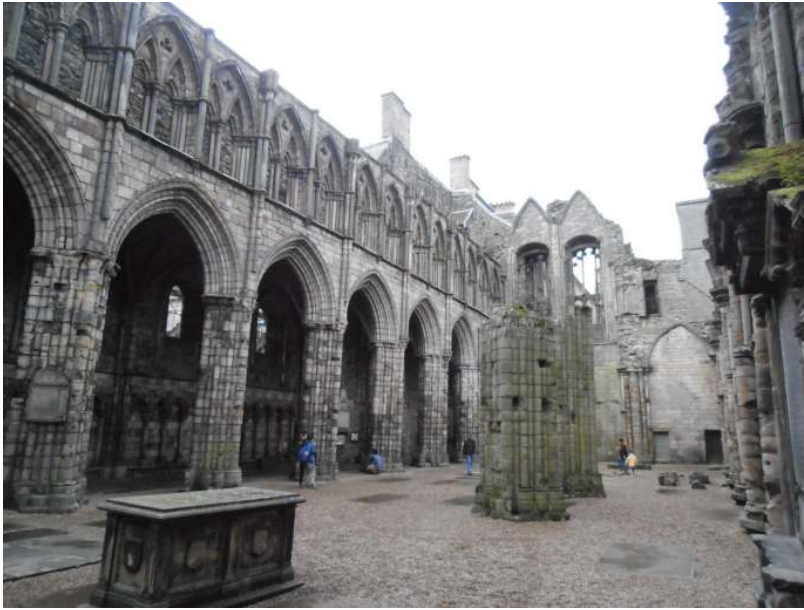
Figure 16. The Abbey church ruins today (2010), showing the two surviving piers of the North arcade.

It is difficult to trace the dynamic of the collapse from the condition of the floor as most of the slate slabs (measuring about 3 x 4 ft) were removed (Fig. 16) and only a few survive towards the East window (confirming potentially that the primary damage happened away from that delicate area). Eventually however the un-braced and exposed East window would be blown down during a storm
